PROTECTION OF MOORING BUOYS  
PART VIII. RESULTS OF SEVENTH  
RATING INSPECTION

June 1966

U. S. NAVAL CIVIL ENGINEERING LABORATORY  
Port Hueneme, California

Technical Report R-458

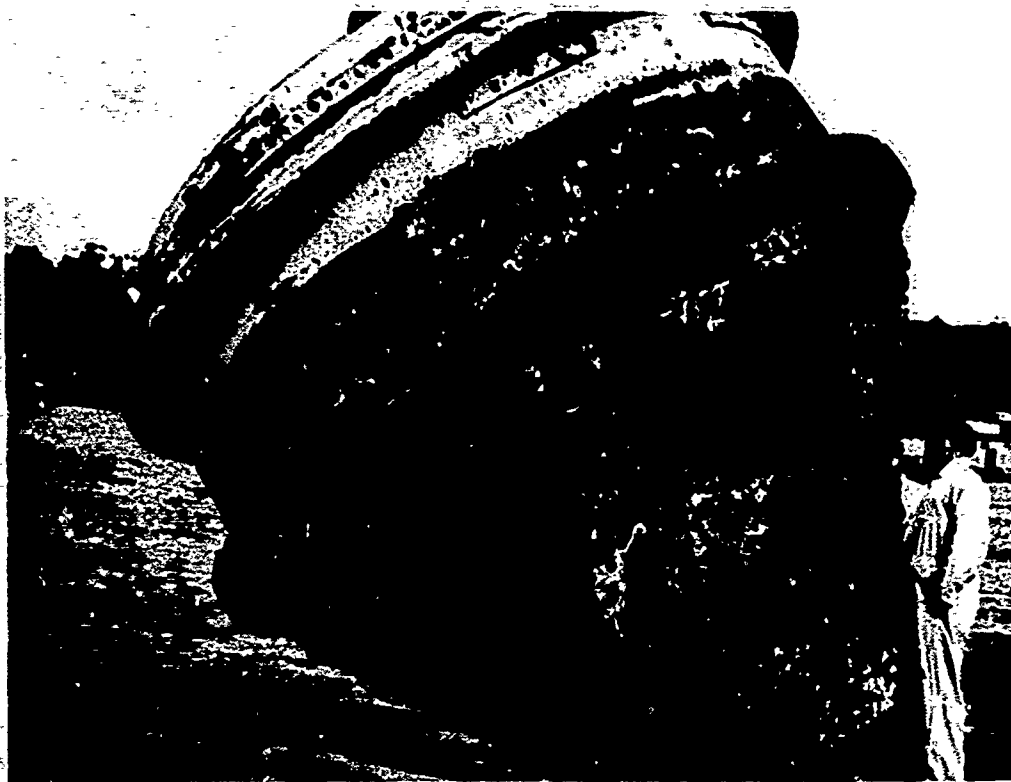
The condition of the System 1 buoy (Figure 1) had changed only slightly since the previous rating inspection. The small blisters in the splash zone noted in that inspection had slight rusting around their edges (Figure 2) and accounted for most of the rusting in this area.

Figure 1. System 1 buoy after removal of fouling.

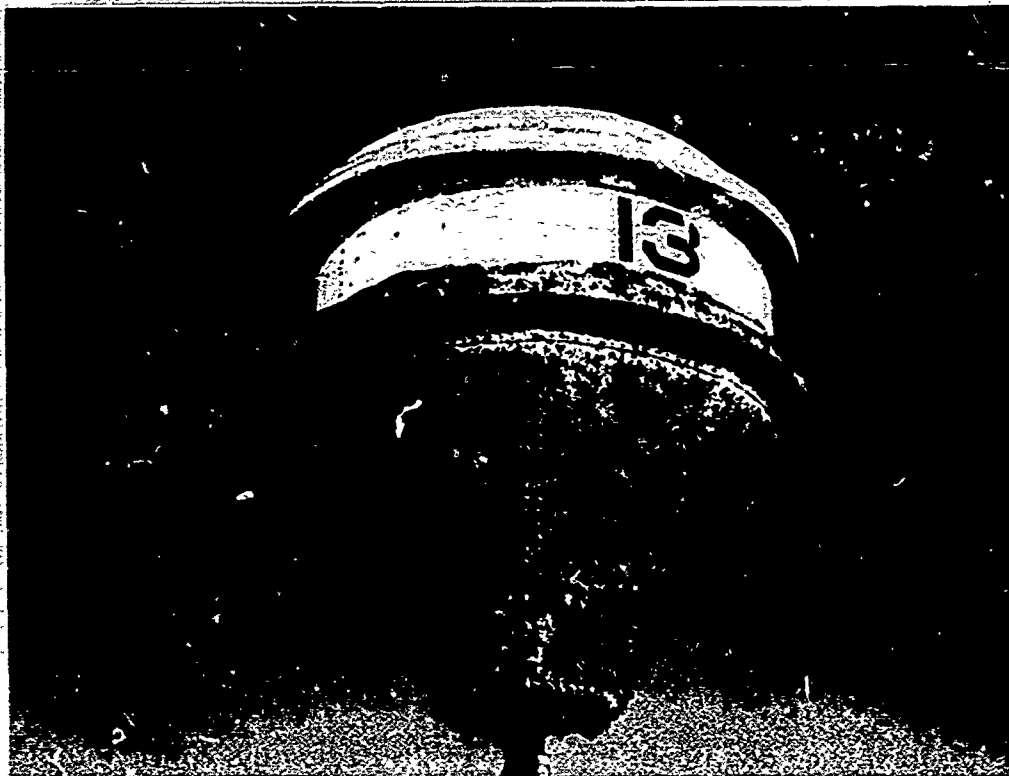
The condition of the System 3 (Figure 6) buoy was essentially unchanged from that noted at the last inspection. The epoxy primer exposed in the submerged zone where much of the polyester topcoats had delaminated was continuing to protect the underlying steel. The rusting in all three zones was related to abrasion damage.

Figure 6. System 3 buoy after removal of fouling.

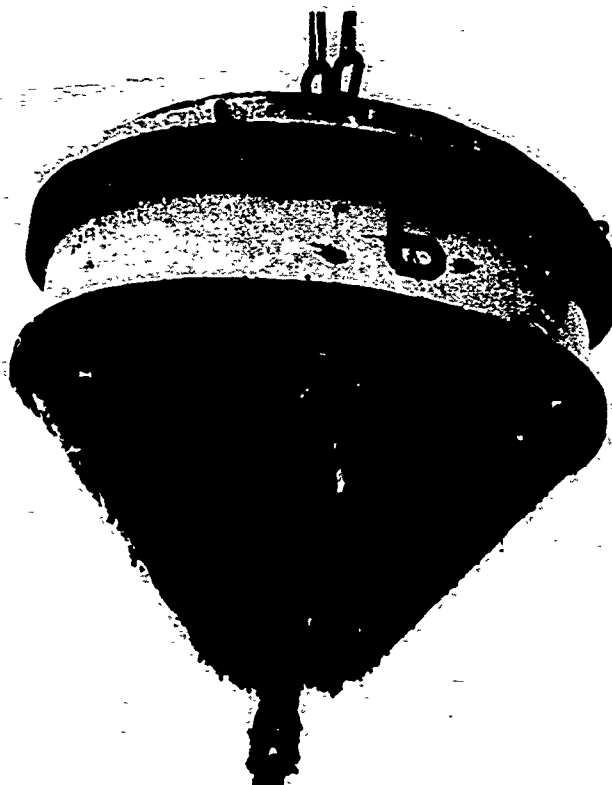
The condition of the System 4 buoy (Figure 7) was essentially unchanged since the last inspection. The previously noted delamination of the topcoat and seal coat in the submerged zone had not advanced significantly since the last inspection, and the underlying epoxy primer and coal tar epoxy were providing good protection to the steel. Elsewhere, the entire coating system was performing well.

Figure 7. System 4 buoy after removal of fouling.

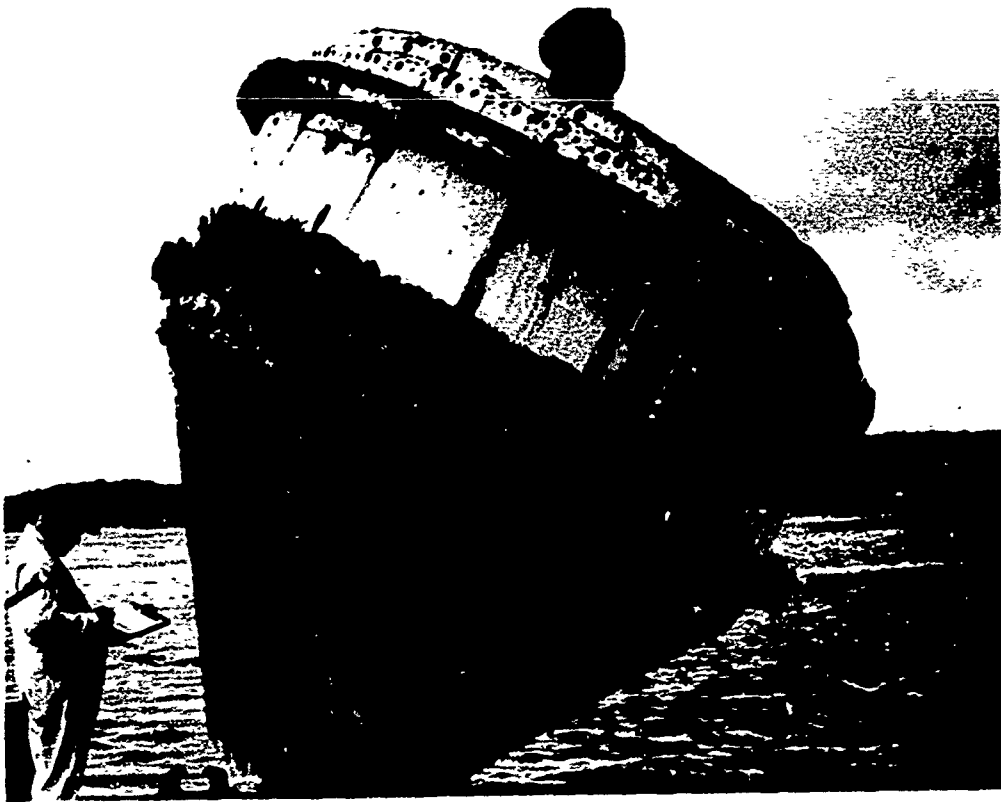
Aside from some additional top rusting initiated by the abrasive action of the securing assembly, the condition of the System 5 buoy (Figure 8) was essentially unchanged since the last inspection. Most of the coating damage in the atmospheric and splash zones was related to abrasion damage.

Figure 8. System 5 buoy after removal of fouling.

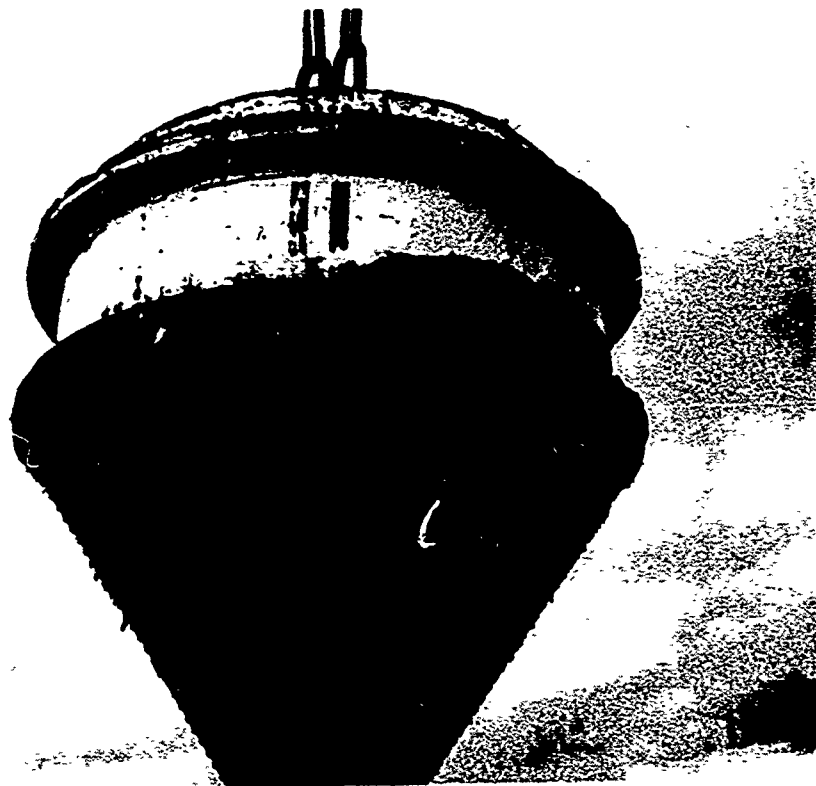
Systems 6 and 6C were identical but the 6C coating was applied to a cathodically protected buoy. Aside from some additional top rusting initiated by the abrasive action of the securing assembly, the condition of both buoys (Figure 9) was essentially unchanged since the last inspection. The System 6 buoy was in slightly poorer condition than the 6C buoy due in large part to its lighter fendering and lack of cathodic protection.

Figure 9. System 6 buoy after removal of fouling.

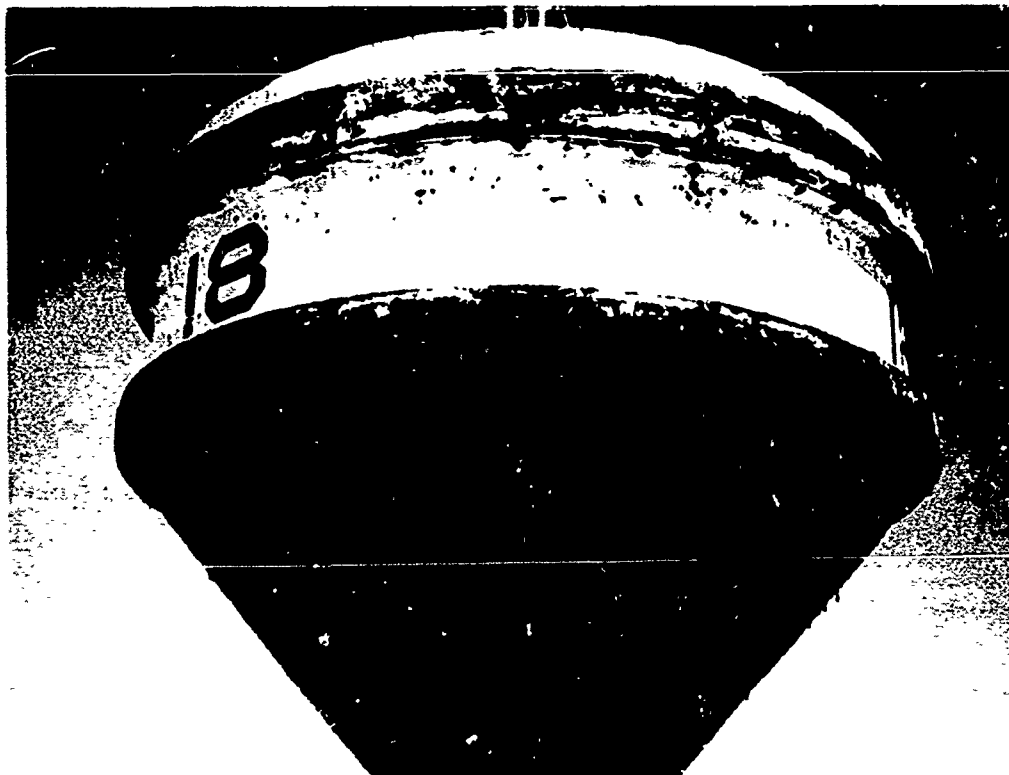
Figure 12. System 8 buoy after removal of fouling.

The condition of the System 8 buoy (Figure 12) had not changed greatly since the last inspection. The submerged portion of this buoy had the identical coating system used on the System 7C buoy, and the condition of the coating system in the submerged zone on both buoys was essentially the same. There was, however, more rusting of steel in this area of the System 8 buoy since it did not receive cathodic protection. Rusting on the side of the buoy was either of the pinpoint variety or had been caused by abrasion.

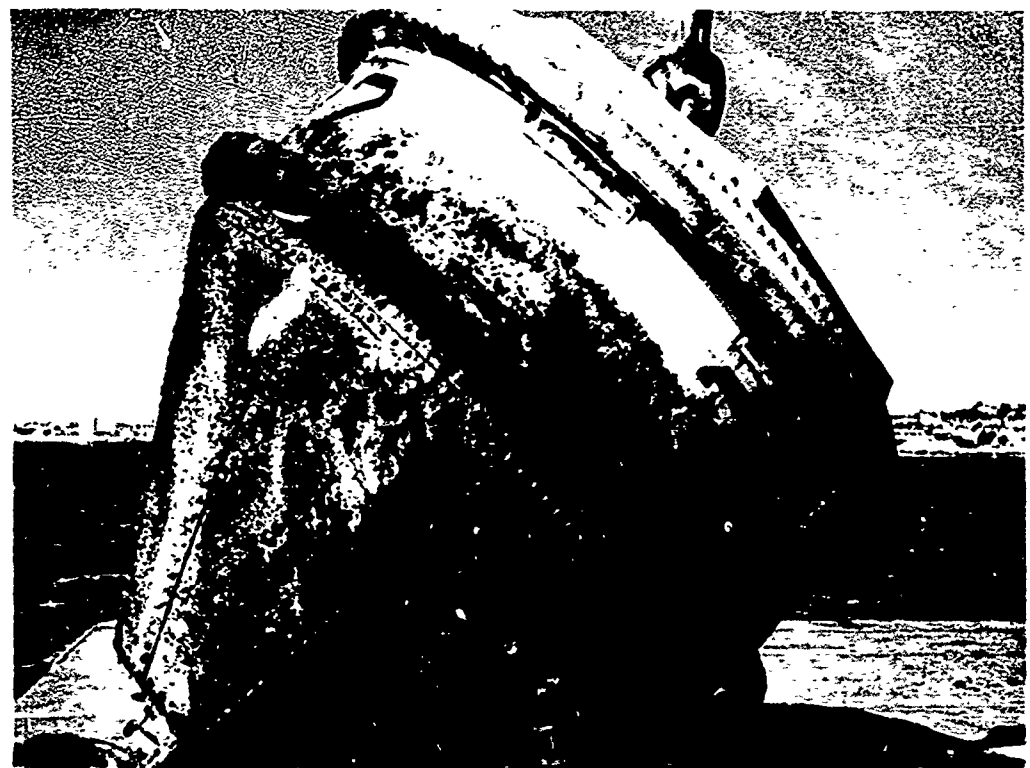
Figure 16. System 9 buoy after epoxy patching.

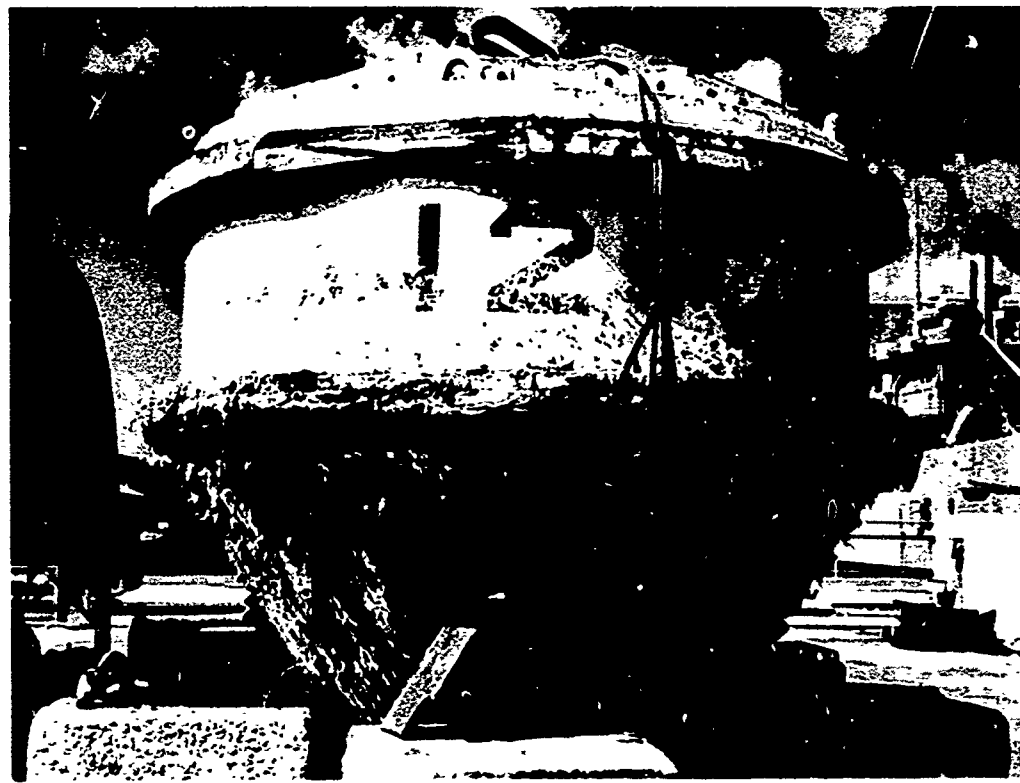
Systems 13 and 13C were identical, but System 13C was applied to a cathodically protected buoy. The former buoy was in the mooring yard (Figure 18) undergoing structural repair at the time of inspection. The condition of the coating on both buoys had not changed greatly since the last inspection. Most of the rusting was due to abrasion or was of the pinpoint variety. The cathodic protection on the System 13C buoy was mitigating corrosion in the submerged area (Figure 19). The square of bare steel (Figure 20) previously exposed on the cone of the System 13C buoy was covered with a thin film of loose rust and had no pitting.

Figure 18. System 13 buoy in mooring yard for structural repair.

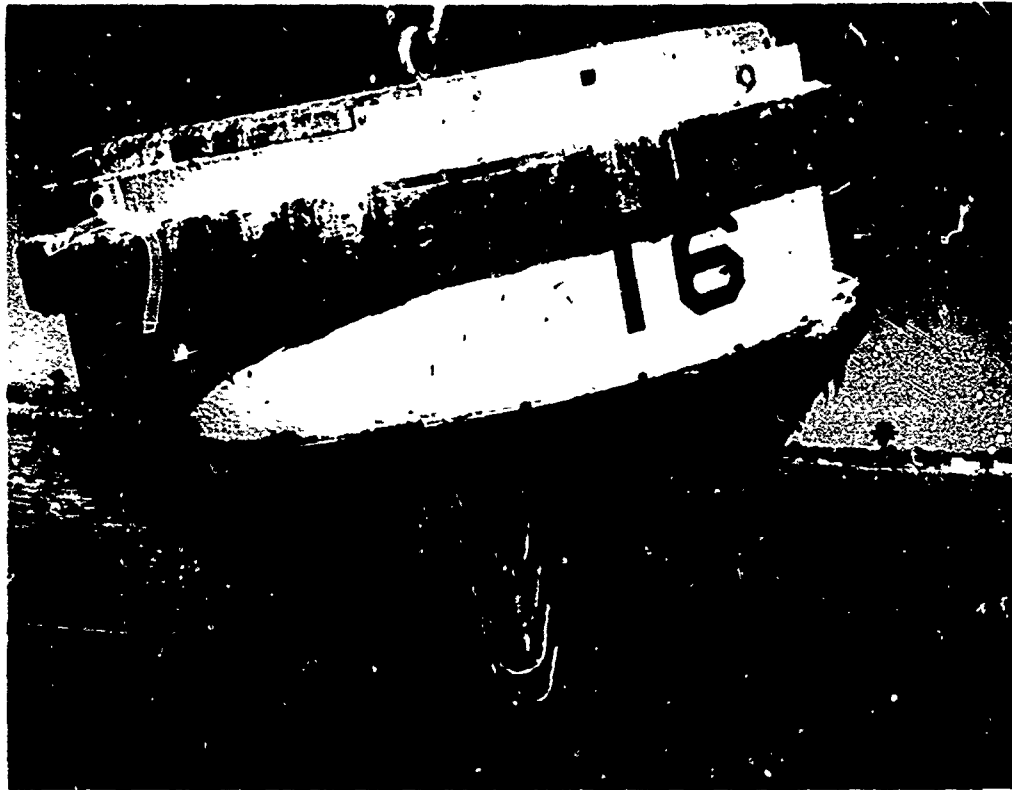
Figure 19. System 13C buoy after removal of fouling.

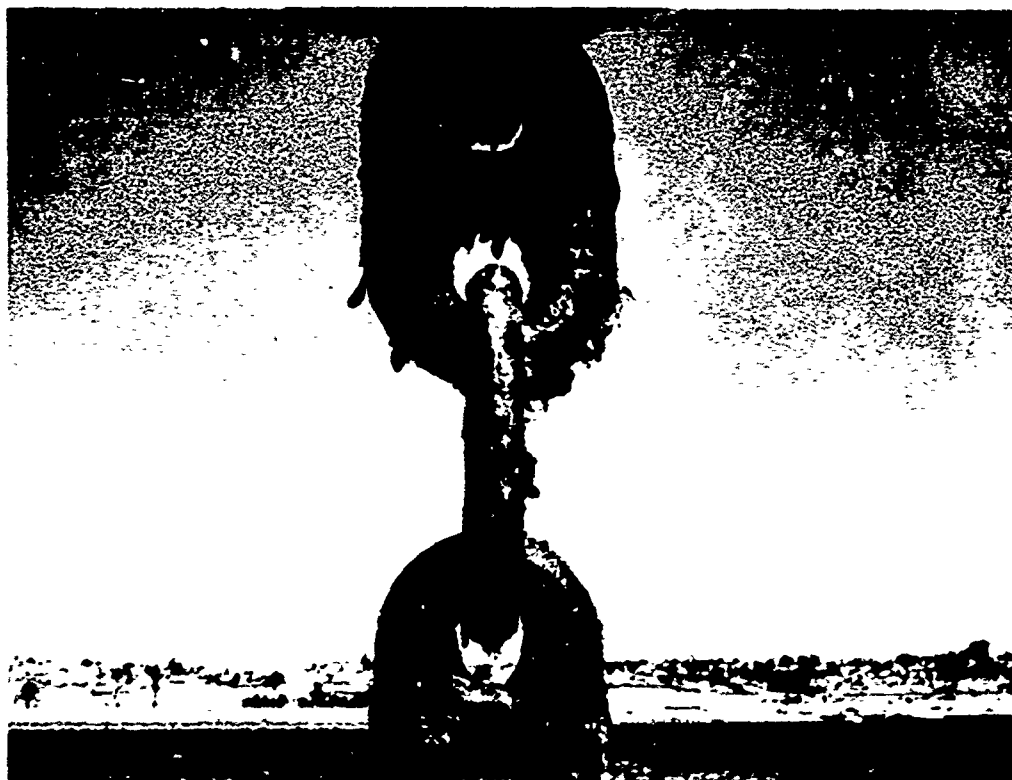
As previously reported,<sup>7</sup> shortly before the previous inspection, all test buoys were picked up and relocated. Because of the tightness of the mooring chains, some of the cathodic protection was transferred from the cathodically protected buoys down the riser chain as has been shown<sup>10</sup> to occur with tight moorings. Potentials measured at the time of the inspection of System 6C, 7C, and 13C buoys were -870, -780, and -820 mv, respectively, as compared to the potentials of a standard silver/silver chloride half-cell. These potentials are quite similar to those recorded at the time of the last inspection, namely -810, -770, and -840 mv, respectively. These potentials for cathodically protected buoys are considerably above the potentials of the unprotected buoys, which have an average value of -670 mv. They are also close to or above the minimum value (-800 mv) considered to be necessary for adequate protection. The riser chains of the protected buoys (Figure 21) had considerably less corrosion and coating loss than the riser chains of the buoys without cathodic protection (Figure 22). The riser chains of the latter had alternate areas of bright and rusted steel indicating active corrosion, while the rust that occurred on the former was in a thin, uniform layer.

Figure 22. Riser chain linkages on System 8 buoy.
